Vermont Urban and Community Forestry:

**An inventory project in order to assess Ash
tree health**

A project done through NR-025 with help from the
Urban Forestry Department

Human Impacts Concerning EAB in Vermont
Fall 2012

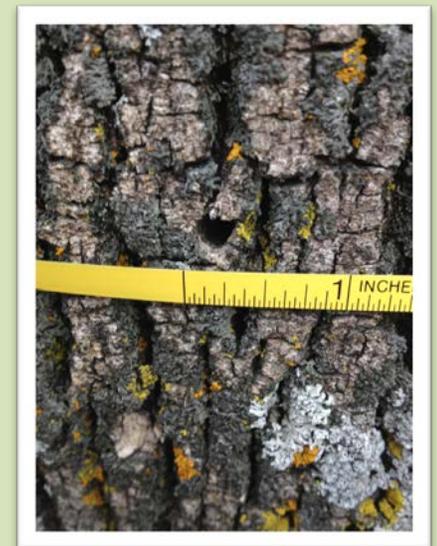
Figure 2: Exit Hole- Photo Credit Amanda Allard

Tree Place mall, we found that most of the Ash street trees in this area were not very healthy. At first, it seemed to the group that these Ash trees had already been exposed to the Emerald Ash Borer because of the amount of exit holes found on trees on

Marshall Ave. After studying the exit holes more extensively, we

realized that most of the holes found on the trees were much more circular, a trait of a native borer, rather than D-shaped, a trait of the Emerald Ash Borer. Although for

the most part this held true, there was one exit hole found on the an Ash tree that looked extremely D-shaped. This finding could be a sign of the Emerald Ash Borer, or more likely could be an exit hole from a slightly deformed native insect.

Discussion and Recommendations: Our management recommendations are to simply keep a close eye on the most at-risk areas of Emerald Ash Borer (EAB) infestation. These areas include the ones listed on the “Most Highly At-Risk Areas” that was provided to us. We noticed things including a lot of decay and insect holes in the bark that indicate the Ash trees which we looked at (in Maple Tree Place, Harvest Ln., and Marshall Ave.) are not in the healthiest of conditions and are therefore much more susceptible to pests such as EAB. Besides keeping up with the conditions of the trees and working to improve them, there is not much more work that can be done.

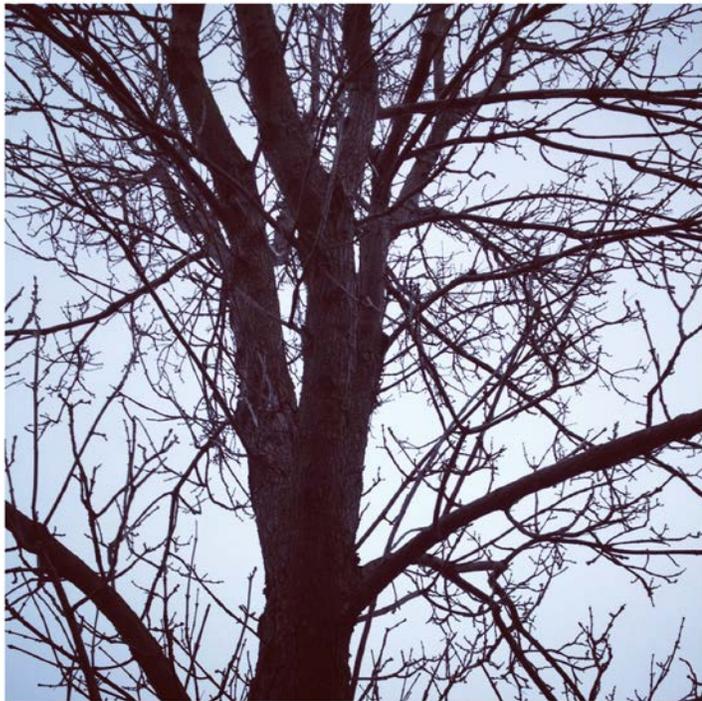
Figure 7: Ash Tree- Photo Credit Tara Gron

trees found in the field had bark that was smoother than normal, which lead the group to assume the trees were in a worse condition. Knowing this information, the trees that were found in the field could be in better condition than initially thought. We also found that the general condition of the street trees in this area was not very good, as you can see in figure 3. The average tree found was either fair or poor and a lot of the trees seemed as if they were decaying.
