Ash Inventory Report for EAB Preparedness; Richford, VT

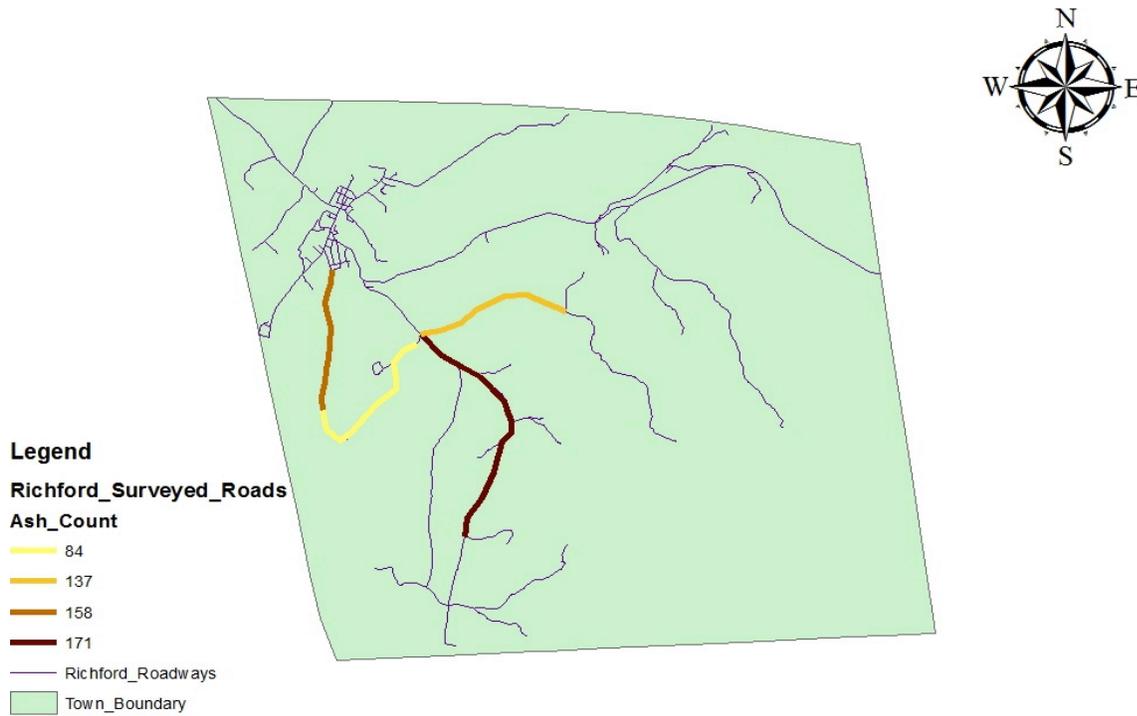
Ash Count for Surveyed Roads; Richford, VT

Figure 1.) Map showing how many individual trees were sampled on four different main roadways in Richford, Vermont on November 10th, and 17th, 2013.

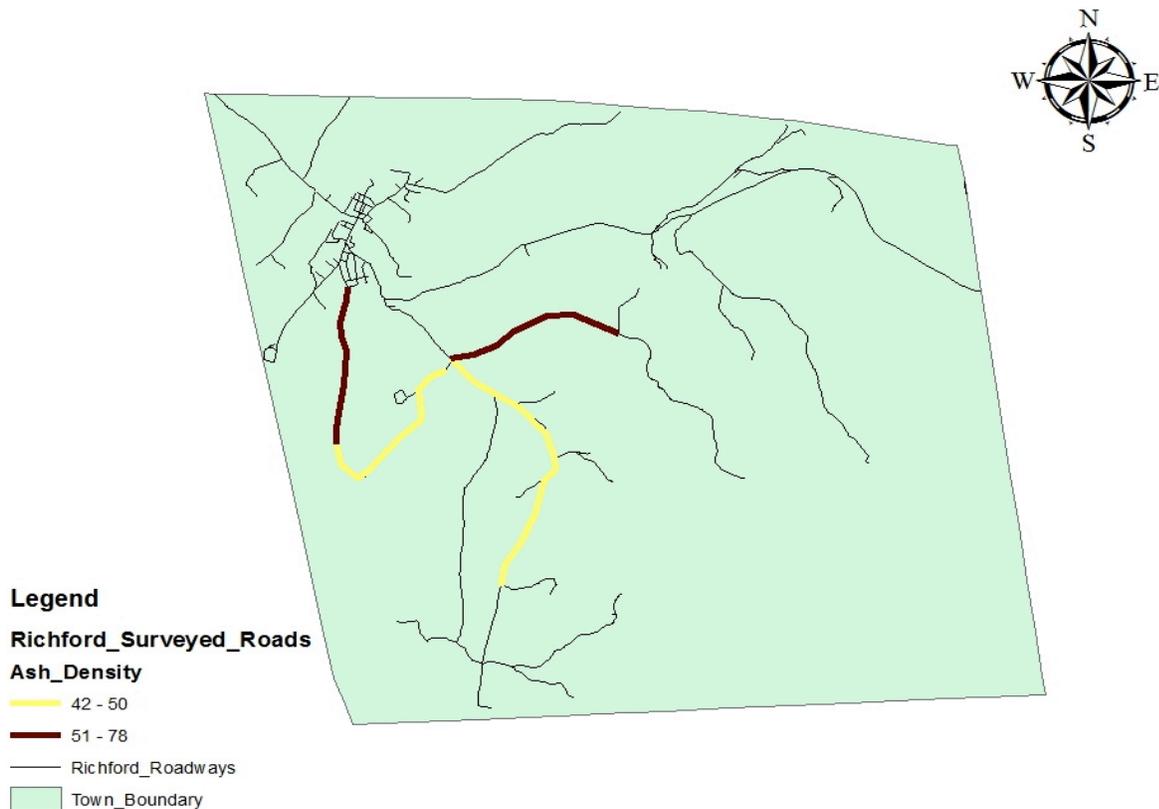
Ash Density (Trees per Mile); Richford, VT

Figure 2.) Map showing the density of trees per mile on four different main roadways in Richford, Vermont on November 10th, and 17th, 2013.
