Vermont Urban and Community Forestry:

**An inventory project in order to assess Ash
tree health**

A project done through NR-025 with help from the
Urban Forestry Department

Human Impacts Concerning EAB in Vermont
Fall 2012

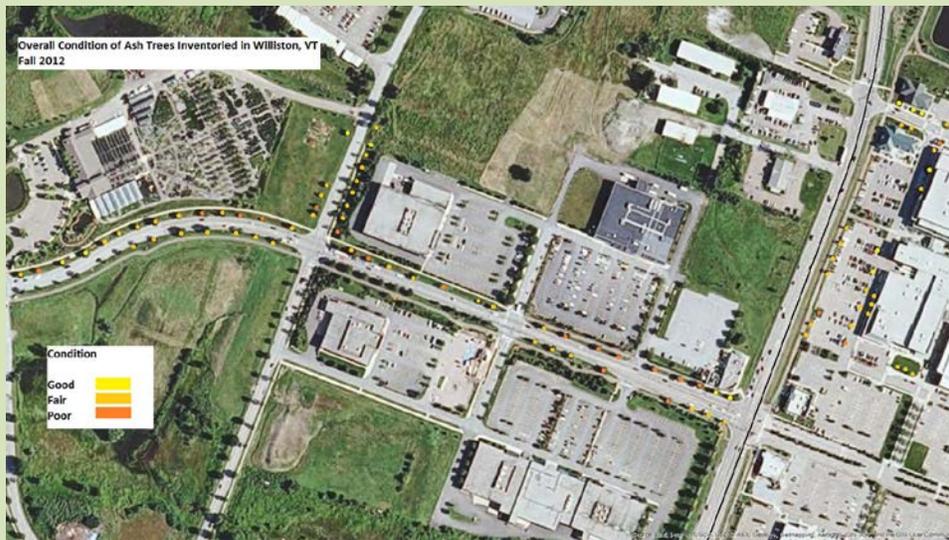
Figure 6: Map of Maple Tree Place and Ash Trees

The next map, figure 5, is a zoomed in map of Williston, which shows the same human factors and high-risk areas that figure 4 had. The last map, figure 6, is map of the area around Maple Tree Place mall complex and points out all the Ash trees inventoried in this project. The different colored dots show the different health conditions that each tree was found in.
